Carlyon Beach HOA
Olympia, WA

Report #: 14933-0
Beginning: January 1, 2026
Expires: December 31, 2026

RESERVE STUDY
"Full"

June 4, 2025

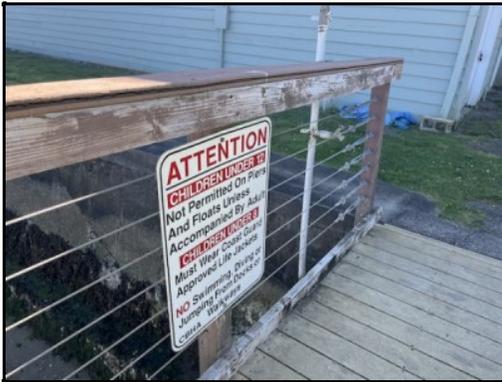
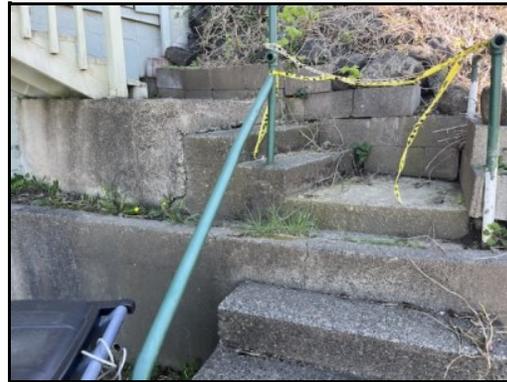
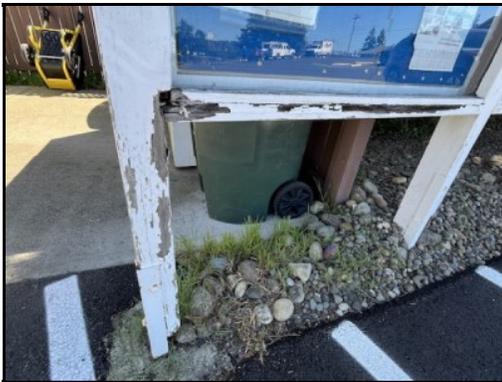
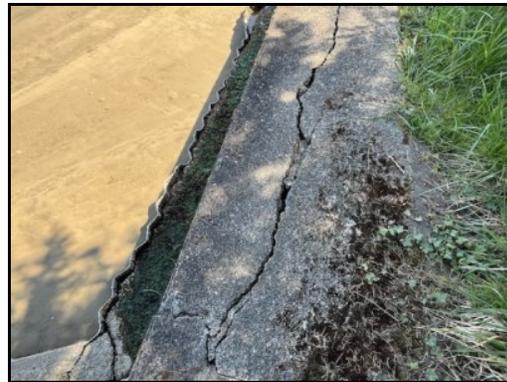
- The metal cables on the wood gangway were loose and could be a hazard to letting things fall through them. We urgently recommend that the cables be tightened to provide adequate safety.
- The stairs on the side of the clubhouse are unstable and could pose a health and safety risk.
- The bulkhead showed areas of cracking, rust seepage and holes at the top where water is draining behind the wall. We recommend that the bulkhead be evaluated by a qualified engineer to establish a plan for remediation.
- The information kiosk appears to be decayed, and could pose a health and safety risk if it were to fall over.

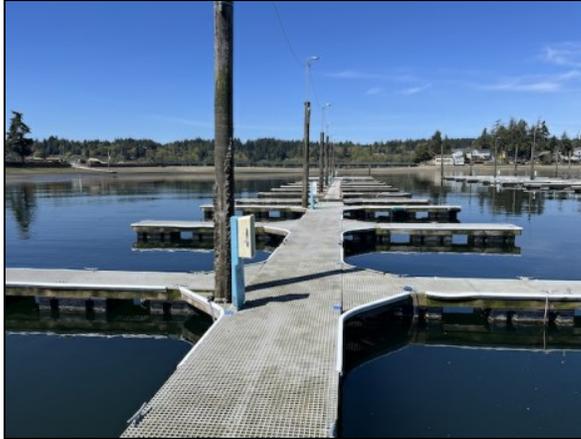
**Lower Estimate:****Higher Estimate:****Cost Source:****Comp #: 1103 Mooring Dock B - Replace****Approx Quantity: 3,900 SF****Location:** Marina**Funded?:** Yes.**History:** 2022-Remaining dock and floats replaced \$131K; 2021, 2018-Partial replacement**Comments:** The dock and fingers of Dock B have been replaced incrementally since 2018. Funding is provided, below, for replacement of the dock and floats, including bollards and plumbing, based on estimates provided for Dock A in 2025.

Additional work may be added to Dock B to install bollards and plumbing. As these plans are developed, include funding in future reserve studies.
