Carlyon Beach HOA
Olympia, WA

Report #: 14933-0
Beginning: January 1, 2026
Expires: December 31, 2026

RESERVE STUDY
"Full"

June 4, 2025

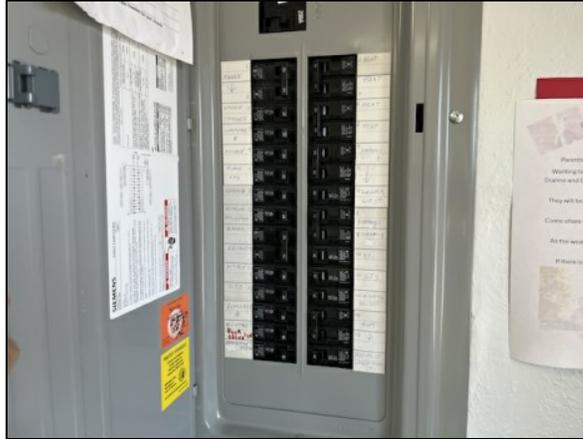
Comments: The majority of the electrical system is not visible for review. Analysis of the electrical system, beyond a limited visual review, is not within the scope of a reserve study. No large issues or problems/defects were reported.

We recommend periodic evaluation by engineer/master electrician to evaluate the system for safety, code-compliance, maintenance, and repair and replacement needs. Any predictable expenses identified that meet the criteria for reserves funding can be included in the reserves plan. Some electrical system components are known to be life limited. Manufacturing defects become known from time to time, and certain site conditions can contribute to premature deterioration of electrical components.

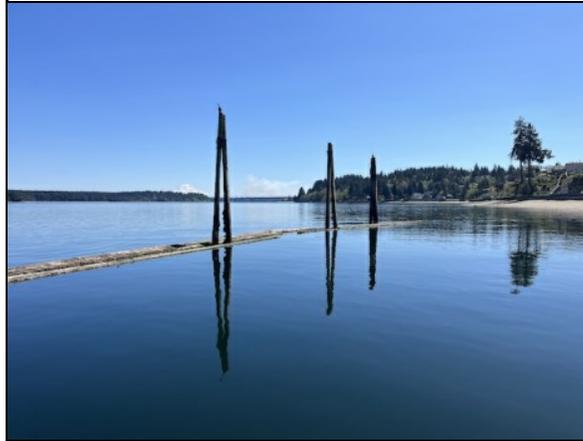
Comp #: 1105 Log Boom - Repair/Replace

Comments: The Association reported that the log boom was due for repairs and partial replacements.

Funding is provided, below, for cyclical repairs and replacements of the log boom. Keep track of actual expenses and update future reserve studies accordingly.

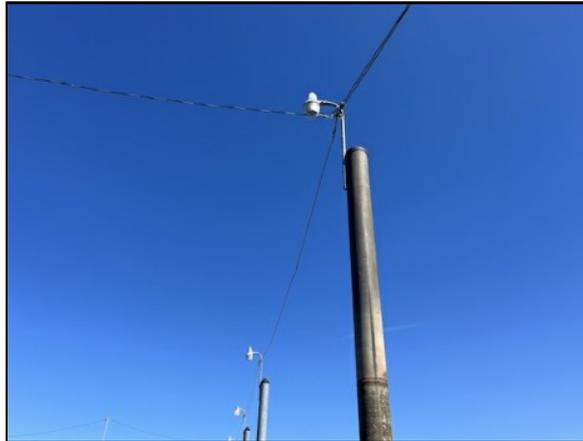
Comp #: 1110 Marina Metal Pilings - Replace

While the useful life of the metal pilings may extend beyond 50 years, due to the corrosive nature of seawater, we recommend budgeting for replacements at roughly the timeline below.

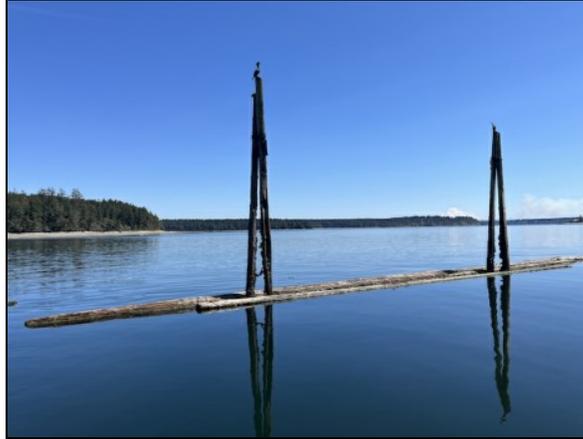
Comp #: 1111 Marina Wood Pilings - Replace

Comments: No professional evaluation of the wood pilings was available at the time of this report. Previous Association documents indicate that the replacement of the wood pilings with required metal pilings was anticipated in 2025/26, but no plans had been made.

Funding is provided, below, for the replacement of the wood pilings in the current fiscal year. Future reserve studies can be updated as evaluations and plans are finalized.

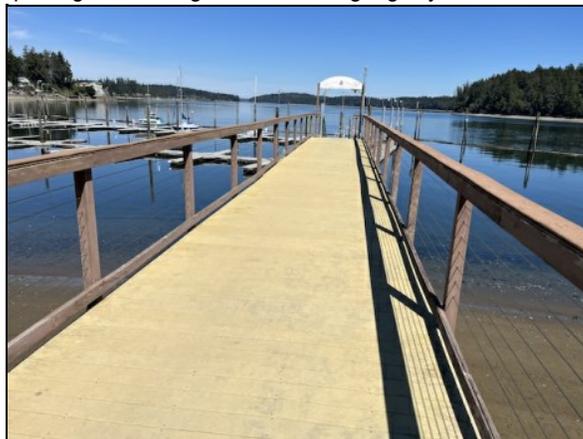
Comments: No problems were reported regarding the structure of the wood gangway. The surface of the gangway appeared worn on it's exterior surface. The metal cables on the railings appeared to be loose, allowing for penetration of larger objects. We recommend that the cables be tightened as a health and safety precaution.

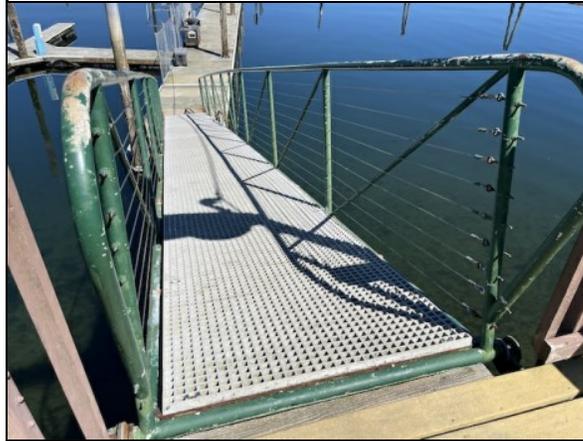
Comp #: 1115 Marina Metal Gangway - Repair/Replace

Comments: No problems were reported of the metal gangway leading to the main dock. The railings showed loss of paint coverage with some rust showing through. The gangway should be evaluated by a qualified engineer.

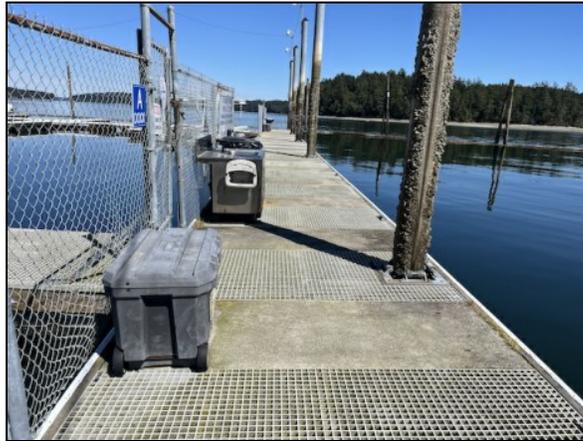
Comp #: 1116 Main Floating Docks - Repair/Replace

Comments: No problems were reported of the main floating dock of the marina. The condition of the dock is best determined by a qualified engineer. The remaining useful life is set, below, according to Association documents and historical satellite imagery.

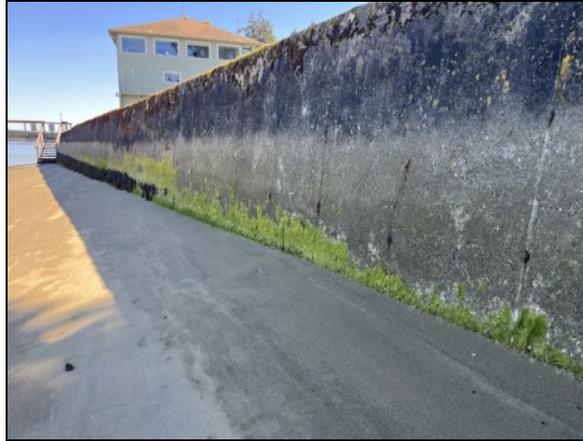
Comp #: 1120 Bulkhead Retaining Walls - Repair

Comments: Association documents indicate a partial repair of the bulkhead in 2014, with the remaining repairs due in 2026. The concrete wall showed some disintegration and areas of rust showing through cracks in the walls.

We recommend a professional evaluation by a qualified engineer to establish a maintenance and repair plan for the bulkhead. Funding is provided, below, based on previous Association documentation.

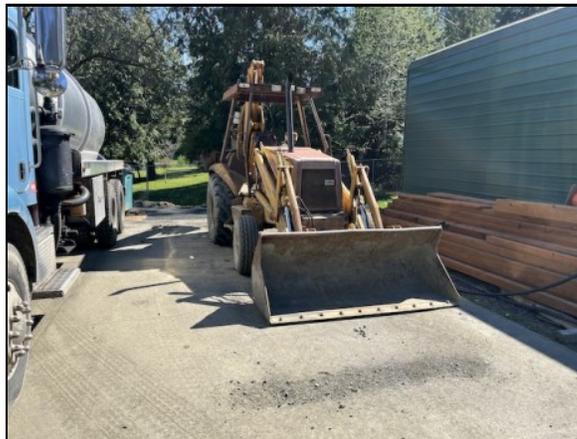
Comp #: 2511 Backhoe - Replace

Comments: Association documents show that the backhoe is repaired as an operating expense as needed. Replacement with a used backhoe is planned for 2028.

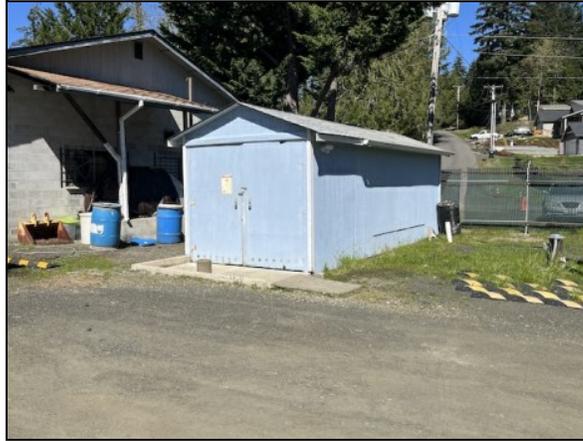
Comp #: 3180 Building, Pump Houses - Replace

Comments: Recommended replacement of pump house buildings recommended by NW Water Systems - Water System Plan 2025.

Useful Life:
70 years

Remaining Life:
27 years

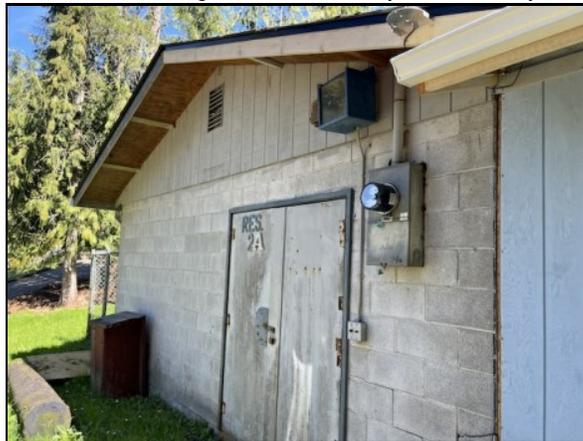
Comp #: 3185 Building, Booster Station - Replace

Comments: Replacement of booster station buildings recommended by NW Water Systems - Water System Plan 2025.

Useful Life:
70 years

Remaining Life:
27 years

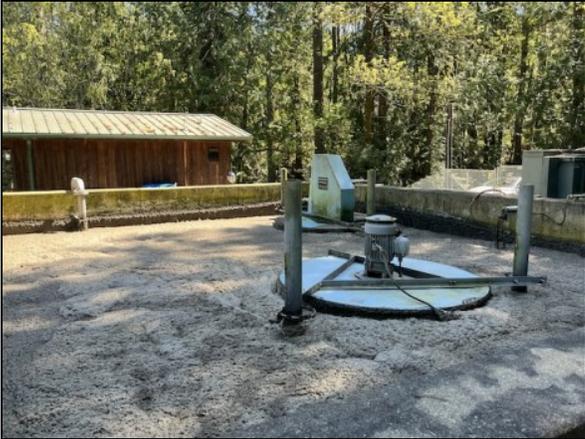
Comp #: 4110 Decanter Unit - Replace

History: 2018-One unit replaced

Comments: The waste water treatment facility has two decanter units. This budget provides funds to replace one decanter unit every 10 years, for a total Useful Life of 20 years per decanter.

Useful Life:
10 years

Remaining Life:
2 years

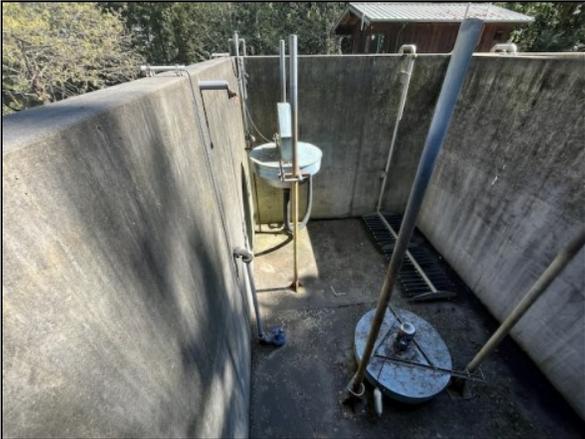
Comp #: 4115 Airation Manifold - Replace

Useful Life:
10 years

Remaining Life:
2 years

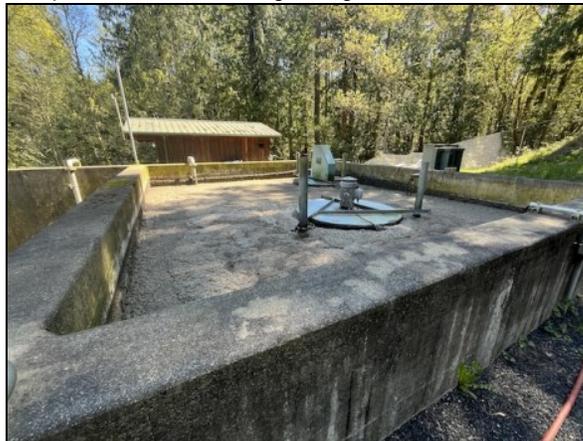
Comp #: 4125 Mixer Unit - Maintain/Replace

Useful Life:
20 years

Remaining Life:
2 years

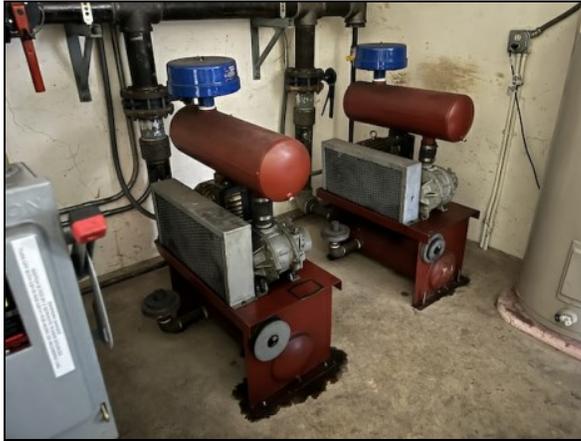
Comp #: 4130 Small Air Compressor - Replace

Remaining Life:

0 years

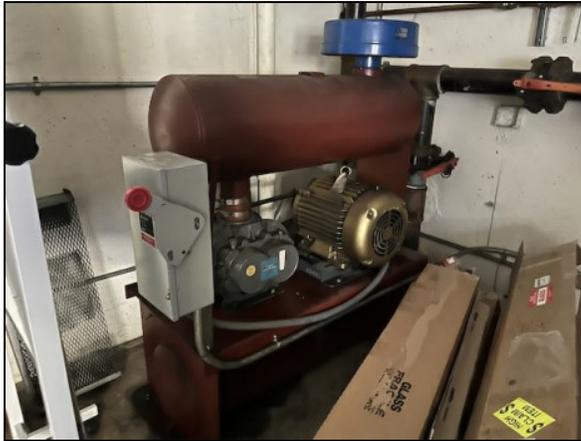
Comp #: 4135 Large Air Compressor - Replace

Remaining Life:

0 years

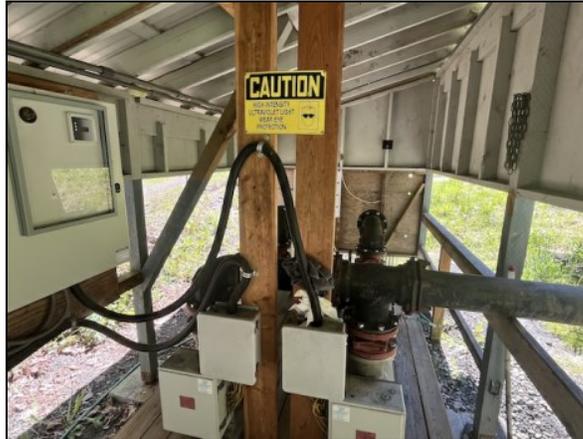
Comp #: 4140 UV Disinfection Controller - Replace

History: 2017-Replaced

Useful Life:
20 years

Remaining Life:
13 years

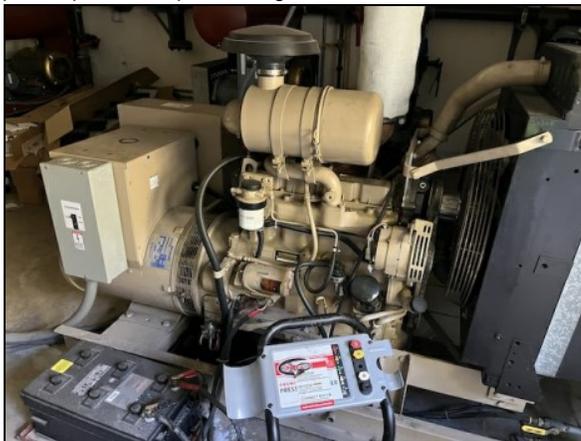
Comp #: 4155 WW Generator - Repair/Replace

History: 2021-Repairs

Comments: The Association reported plans to replace the generator in 2025.

Remaining Life:

0 years

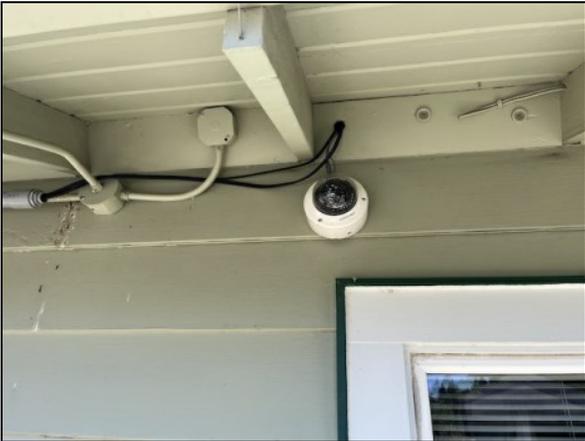
Comp #: 945 Surveillance System - Repair/Replace

History: 2018-Replacement of surveillance cameras

Useful Life:
10 years

Remaining Life:
2 years

Although it is difficult to predict the timing, cost, and scope of future replacement, we suggest a general funding allowance for periodic upgrades and significant repair/replacements. Costs and timing can vary greatly depending upon the number and quality of the cameras, and other system specifications. Expect some local repair/replacement maintained with operating funds in between overhaul cycles.
